HELICOPTER ICING SPRAY SYSTEM (HISS) EVALUATION AND IMPROVEMENTS

APRIL 1986

FINAL REPORT

UNITED STATES ARMY AVIATION ENGINEERING FLIGHT ACTIVITY
EDWARDS AIR FORCE BASE, CALIFORNIA 93523

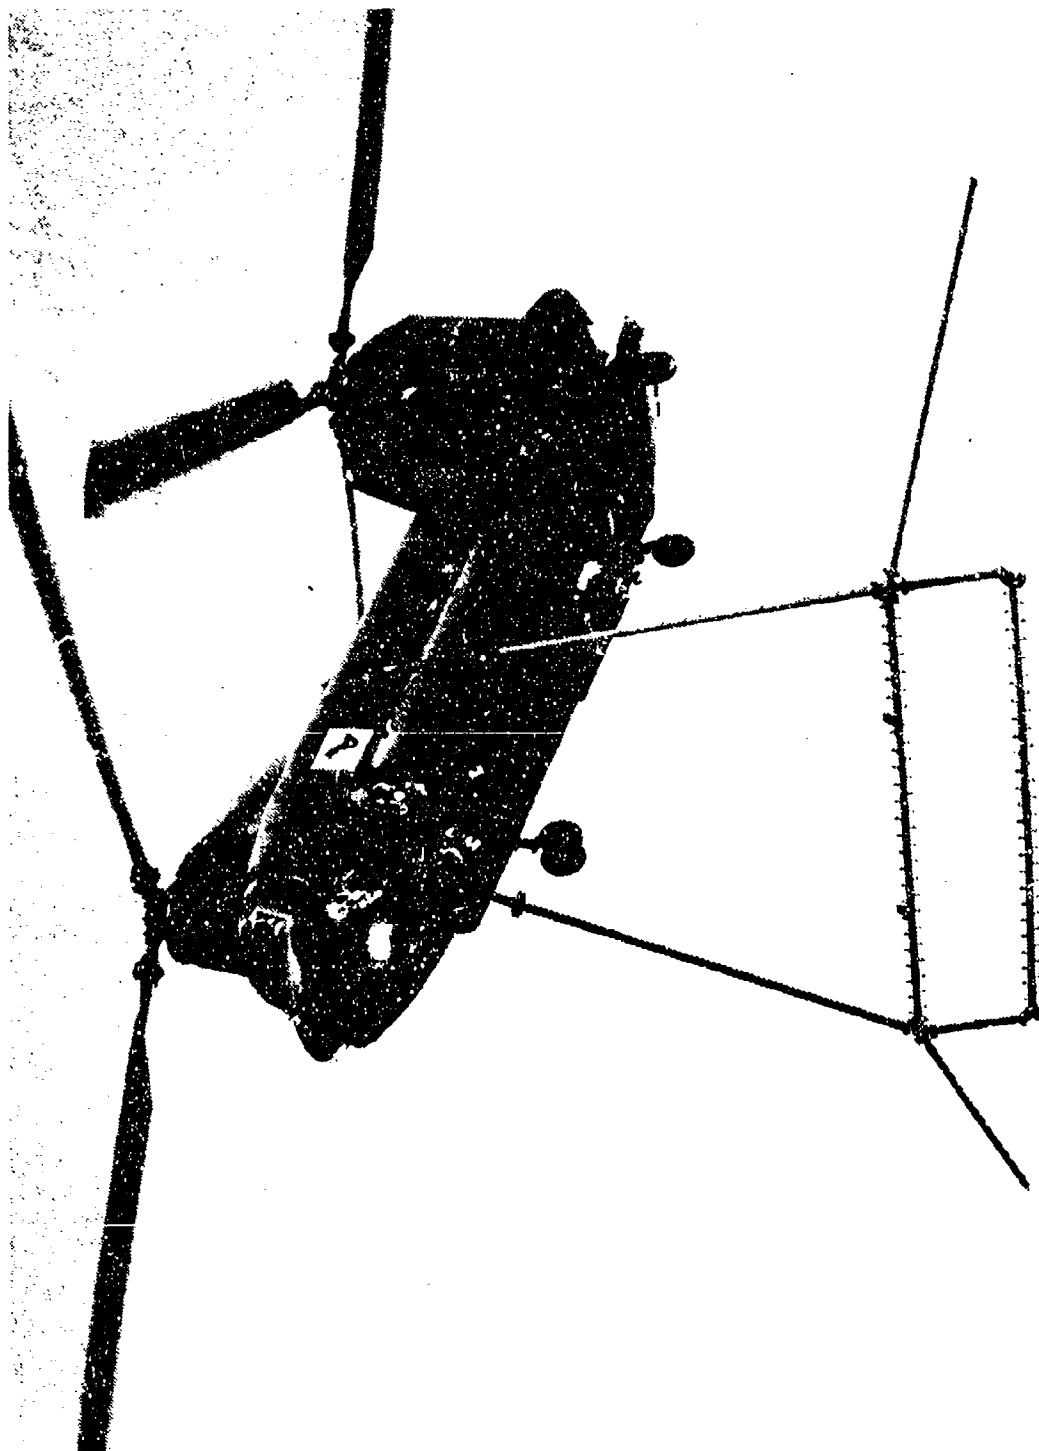
Photo A. JCH-47C Helicopter with HISS Installation

3. The HISS, shown in photo A and further described in appendix B, is installed in a modified CH-47C helicopter (US Army S/N 68-15814). It consists of an internal water tank and an external spray boom assembly suspended beneath the aircraft from a torque tube through the cargo compartment. Hydraulic actuators rotate the torque tube to raise and lower the boom assembly. The boom is constructed of concentric metal pipe, forming an upper and lower trapeze located between two outrigger sections, with an overall tip-to-tip width of 60 ft. The outer pipe is the structural trapeze and boom assembly, and is pressurized with bleed air from the aircraft engines and an auxiliary power unit (APU). The inner pipe acts as the water passage. Water and bleed air are supplied to spray nozzles spaced along the boom to atomize the water and form the spray cloud. Water flow rate is controlled to vary the cloud liquid water content (LWC).

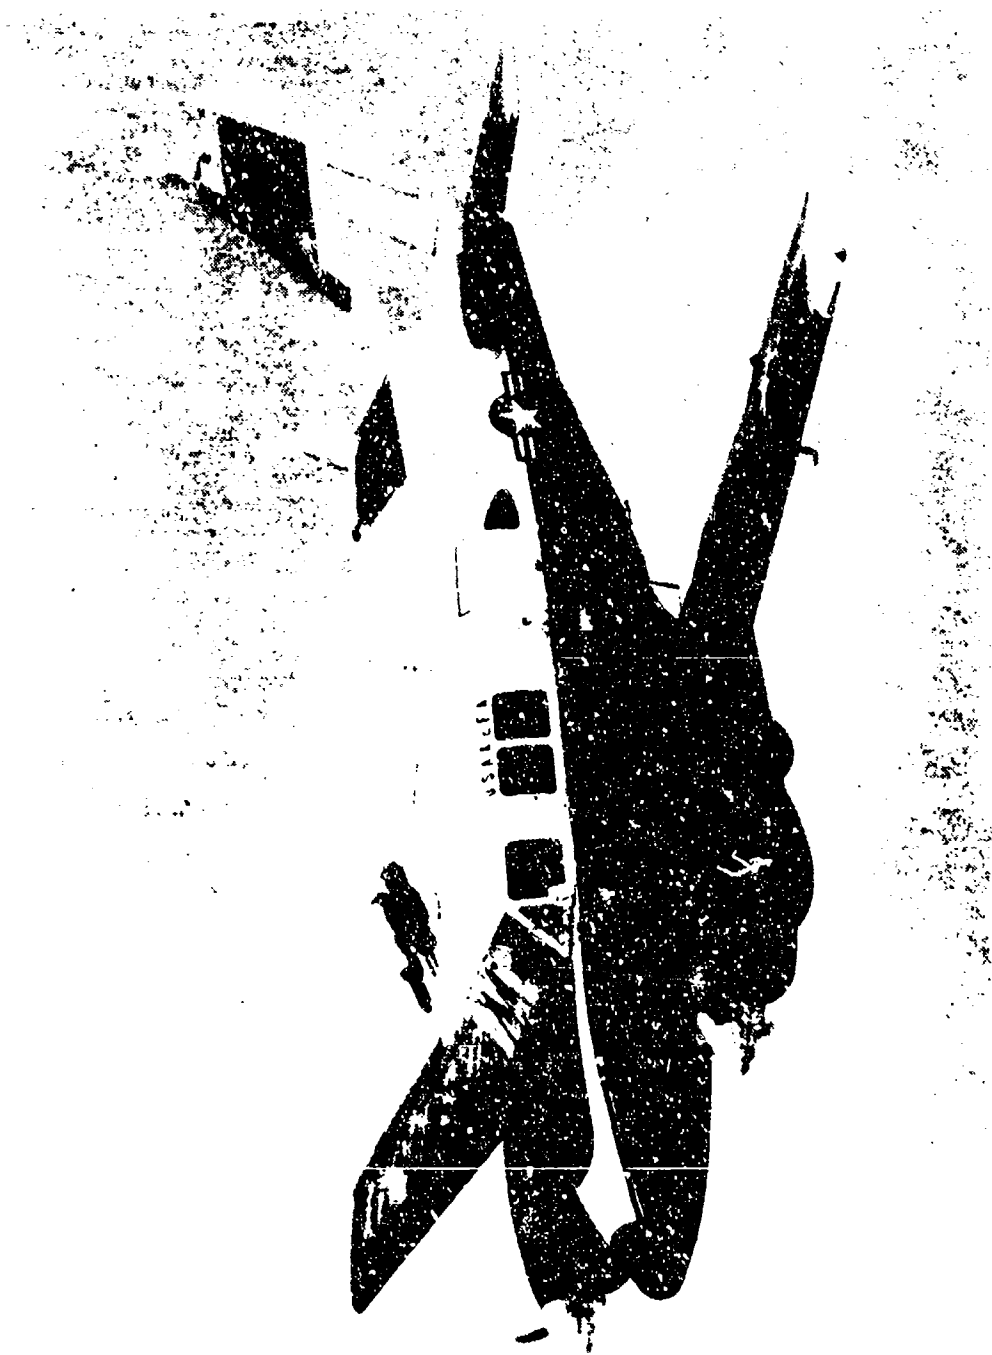
Photo B. JU-21A Aircraft with Cloud Measuring Equipment

7. The calibration aircraft used to sample the spray cloud was a JU-21A fixed wing aircraft (US Army S/N 66-18008) shown in photo B. Onboard instrumentation included two Particle Measuring Systems, Inc. (PMS) laser spectrometers (models FSSP-100 and OAP-200X), a Leigh MK 10 ice detector, a Cloud Technology, Inc. LWC sensor, a Rosemount total air temperature probe, and a Cambridge dew point hygrometer. The data acquisition system installed was a Small Intelligent Icing Data System for recording and processing the instrumentation signals. The particle counting and sizing capabilities of the PMS laser spectrometers provided a description of drop size distributions for diameters between 2 and 300 microns, and allowed a calculation of median volumetric diameter and LWC. A more detailed description of the aircraft and cloud measurement system is contained in appendix C, and the data analysis techniques are described in appendix D.

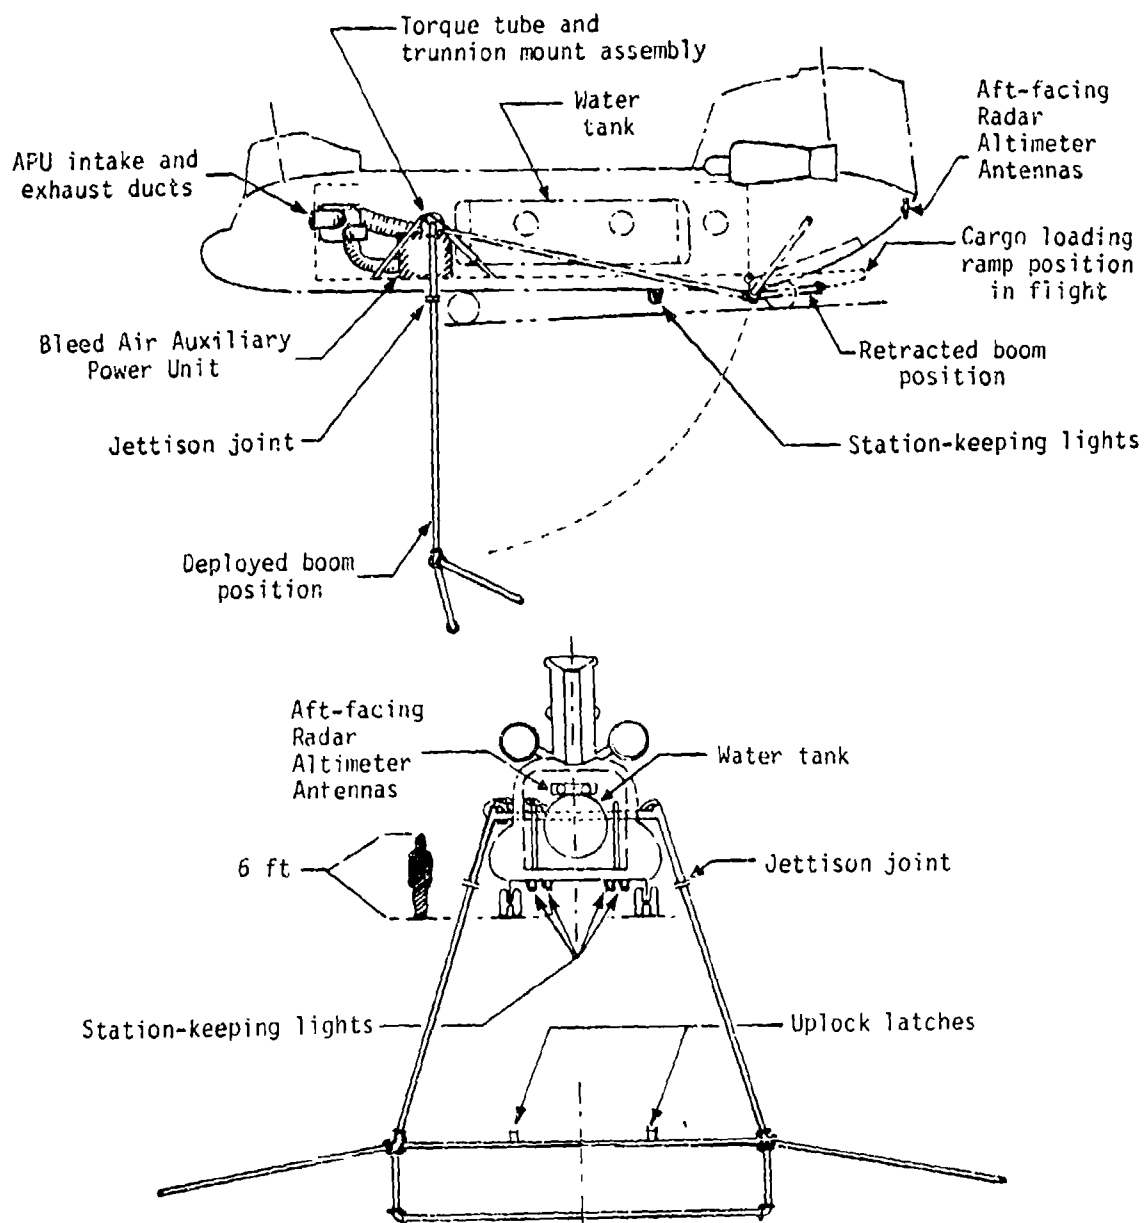
Figure A. Helicopter Icing Spray System
Side and Rear View Schematic

3. The boom assembly consists of two parallel 27 ft trapeze sections with 5 ft vertical separators, and two 17.6 ft outriggers attached by 4-way junctions to the upper trapeze. When lowered, the outriggers are swept aft 20° and angled down 10° giving a tip to tip boom width of 60 ft. Skid plates at each corner of the lower trapeze allow a forward hover landing without damage to the boom or nozzles if the boom fails to retract. The boom is constructed of concentric metal pipe. The outer pipe (4 in. diameter) is the structural trapeze and outrigger assembly and provides a passage for bleed air. Water is pumped through the inner pipe at selected flow rates from the tank to the nozzles on the boom assembly. The water passages originally had a 1-1/2 inch diameter throughout. Between the 1984 and 1985 icing seasons, the water tube sections within the upper and lower trapeze were changed to one inch diameter. After the 1985 season, the remaining sections in the boom supports and cabin interior were also modified, converting the entire water system to one inch diameter. Thirty manifolds for distributing water to the nozzles are spaced approximately three ft apart along the boom exterior. Aircraft

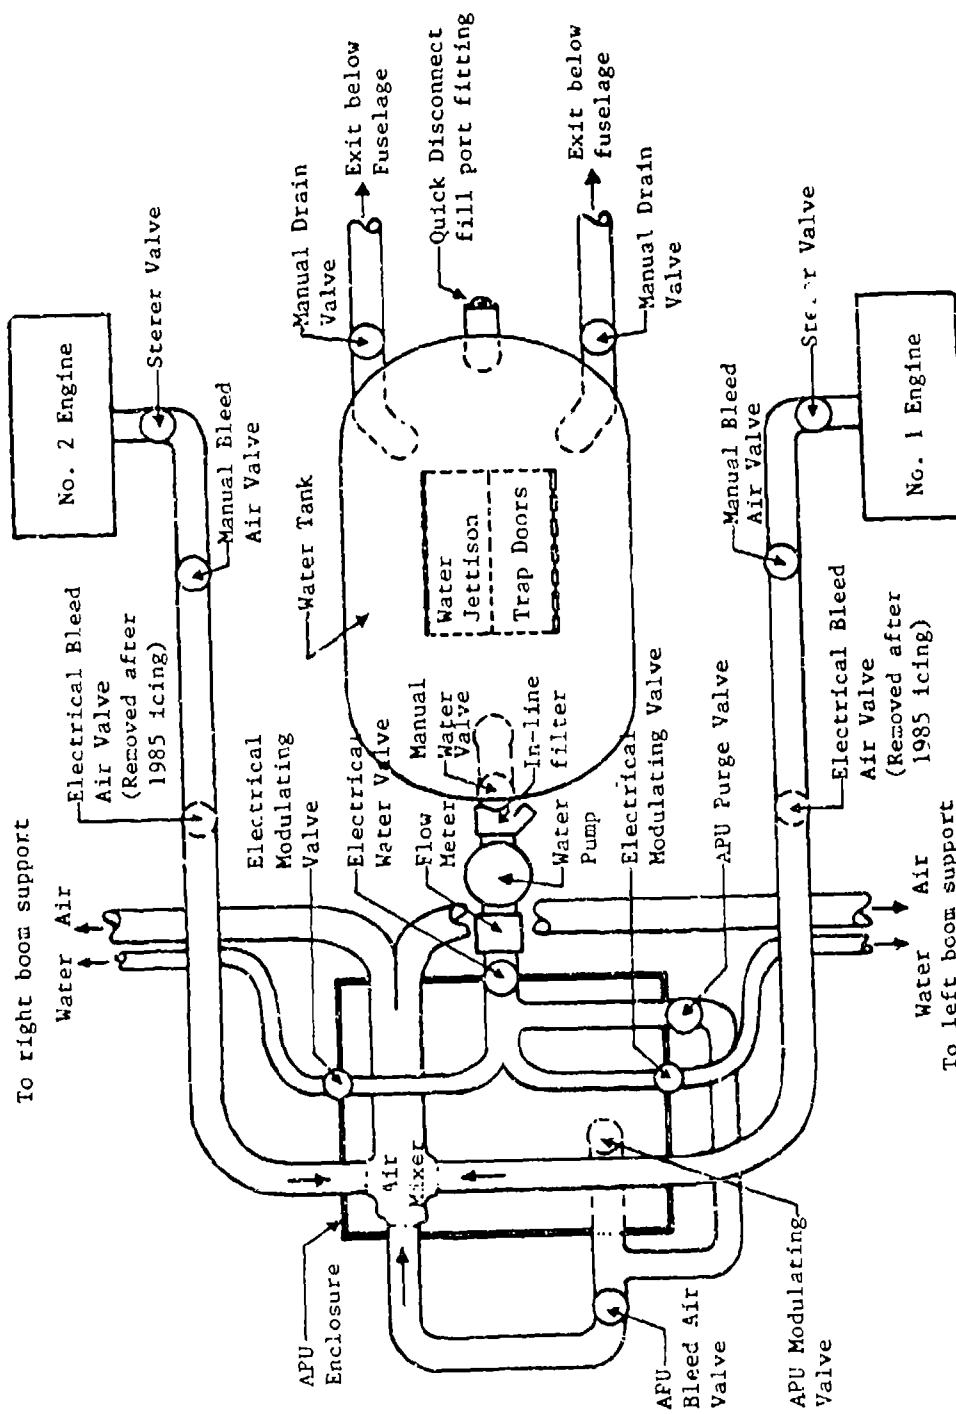
Figure B. Helicopter Icing Spray System Air and Water Distribution System

engine compressor bleed air and bleed air from a Solar T-62T-40C2 auxiliary power unit (APU) are supplied through the outer pipe to the nozzles for atomization. Figure B shows a schematic of the current air and water distribution system.

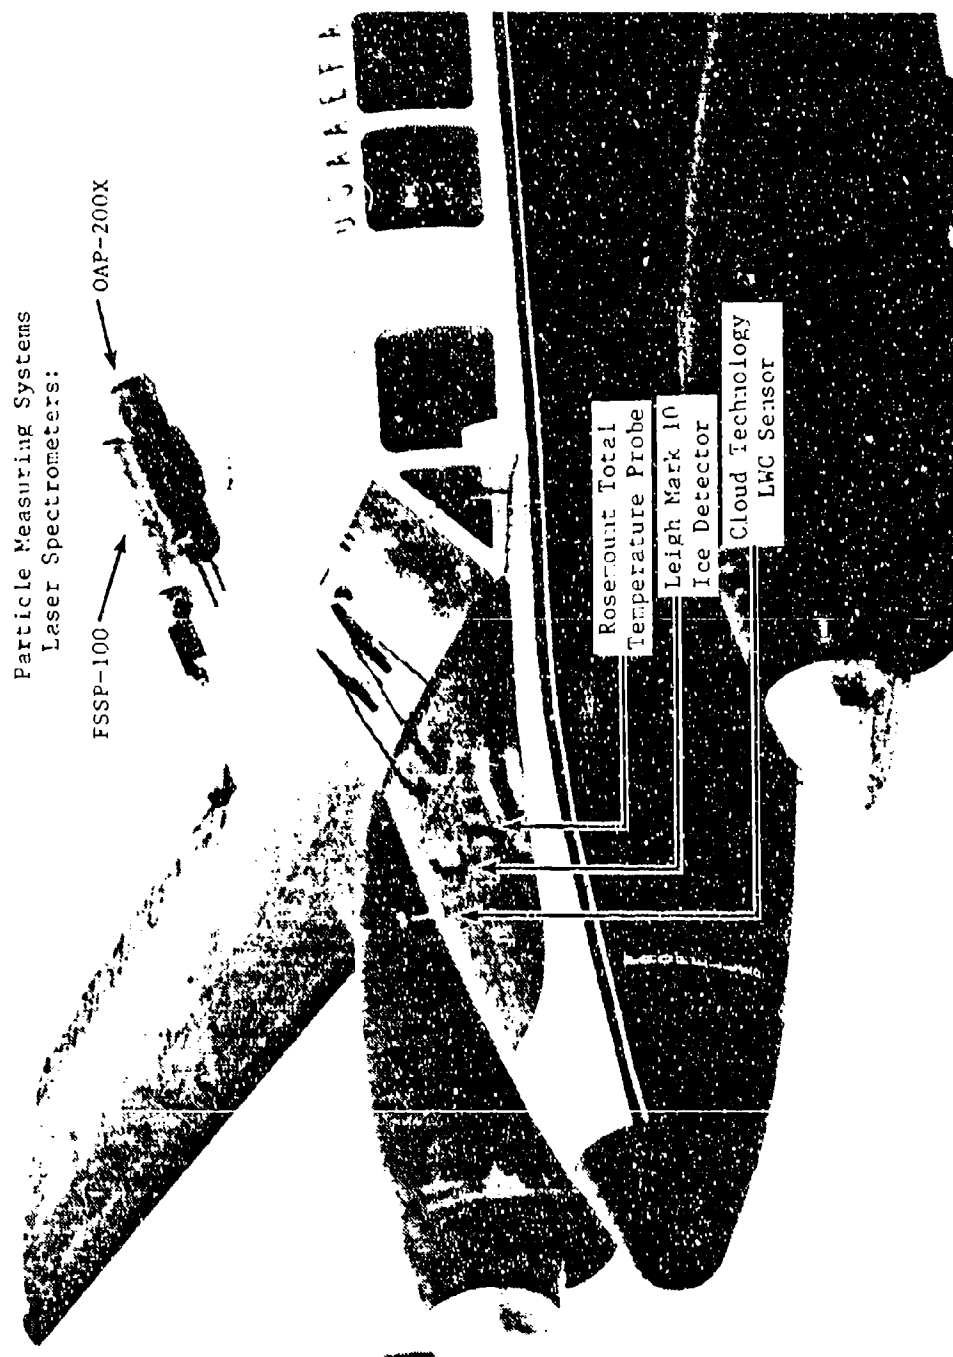
Photo 1. Cloud Measuring Instrumentation on JU-21A

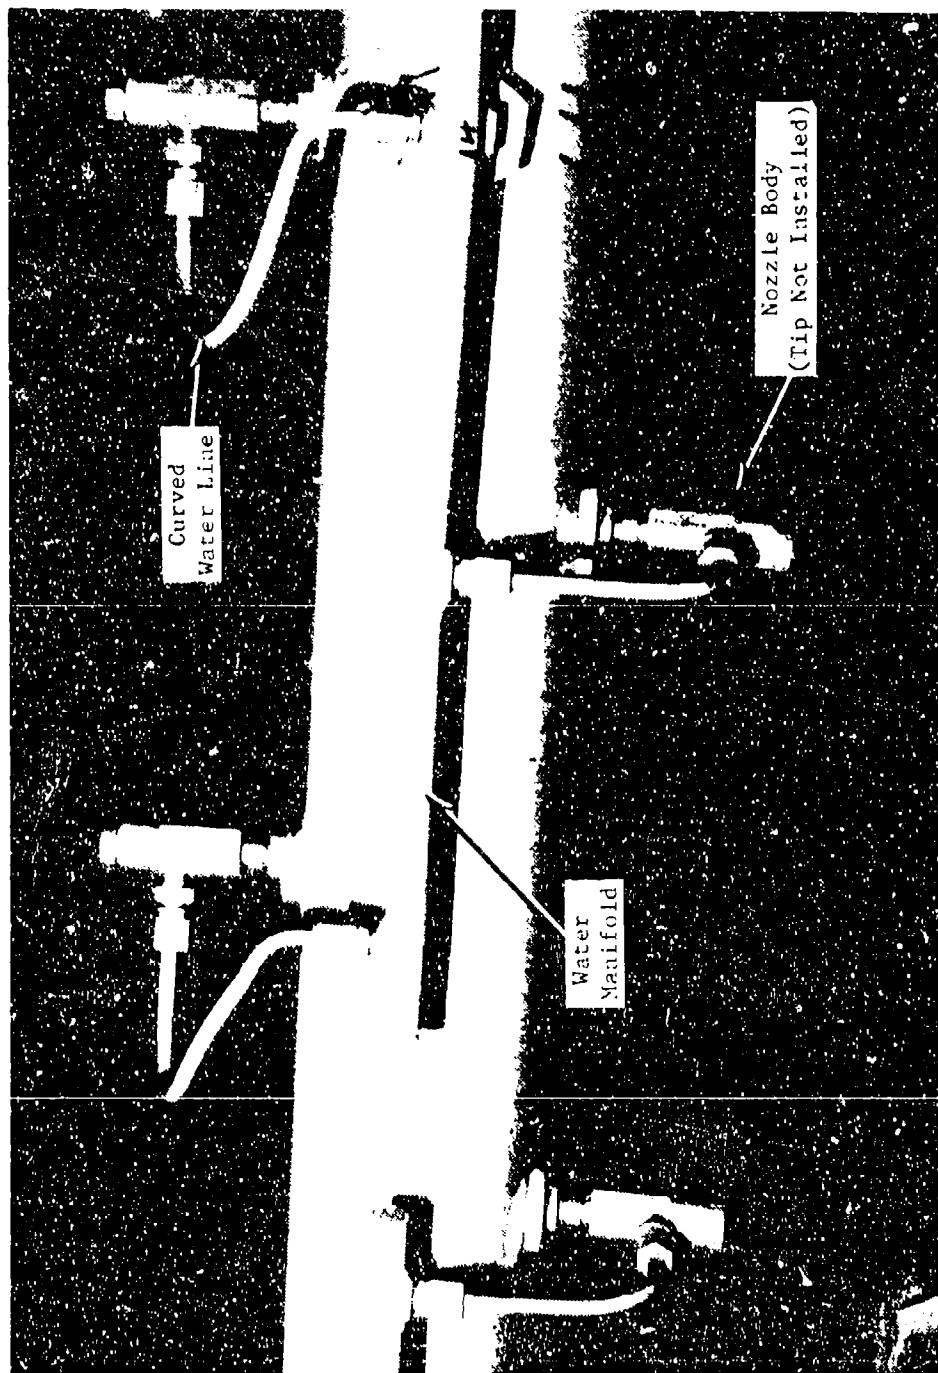
Photo 1. Curved Water Feed Lines Installed For Upward-Facing Nozzles

11. The initial 1984 icing flights with the "T" shaped water manifolds resulted in formation of ice on the upward facing rows of nozzles. As described in paragraph 17, the downward facing nozzles were not affected because of orientation differences and local airflow effects. The water feed lines for all nozzles on both upper rows were replaced with aluminum tubing curved to one side as shown in photo 1, appendix E. This curved tubing no longer projected directly behind the top row nozzle bodies, and ice formation on the water lines was eliminated.

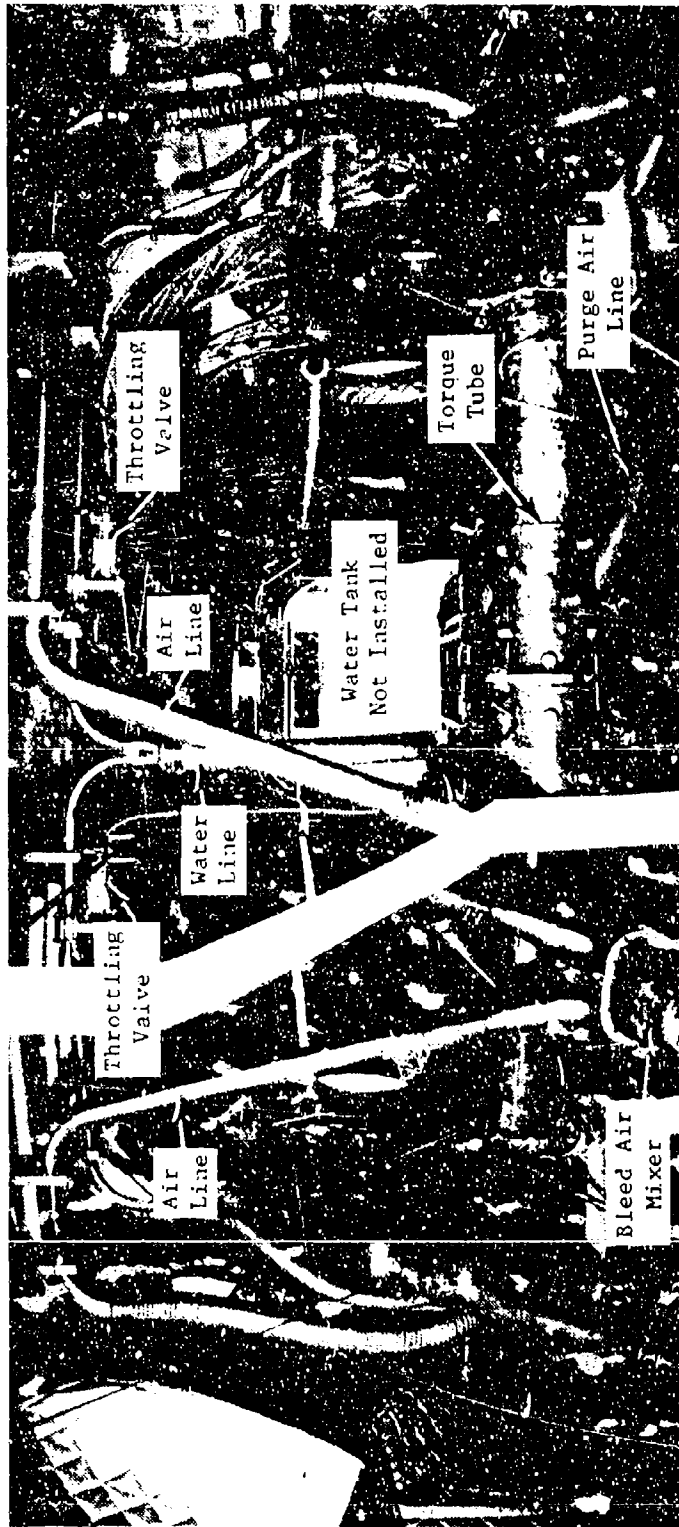
Photo 4. Stainless Steel Air Line Installation

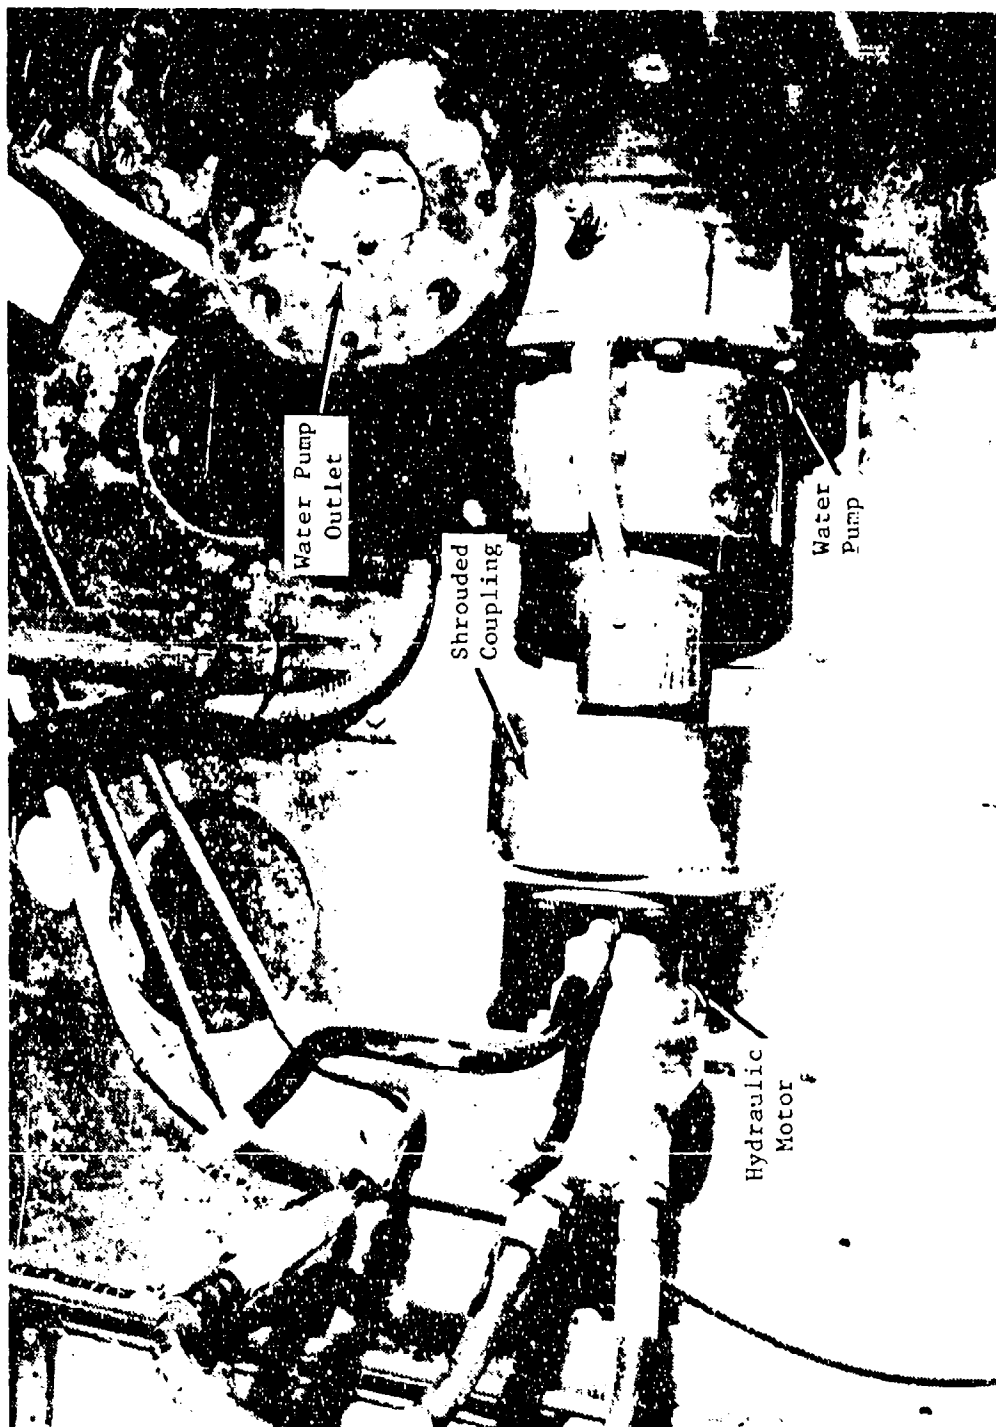
Photo 5. Hydraulic Motor and Water Pump Assembly

15. Rupture of bleed air hoses and malfunction of the water pump caused recurring difficulties during operation (para 16). To reduce incidence of such problems, these systems were modified after completion of the 1985 icing tests. The long sections of 2 inch flexible hose connecting the bleed air mixer assembly outlets with each of the boom entry points were replaced by 2 inch diameter stainless steel tubing, as shown in photo 4, appendix E. Short hose sections remained to connect the tubing gaps and accommodate line movement caused by rotation of the torque tube when raising and lowering the boom. The hydraulic motor driving the water pump was replaced with a larger unit better suited for sustained operation. A thicker mounting base-plate was installed to improve alignment, and the type of coupling between motor and pump was changed from one with press-fit neoprene bushings to one with sprockets and a roller chain connection. The replacement motor unit and coupling installation are shown in photos 5 and 6, appendix E. For comparison, the original assembly can be seen in photo 2, appendix H.

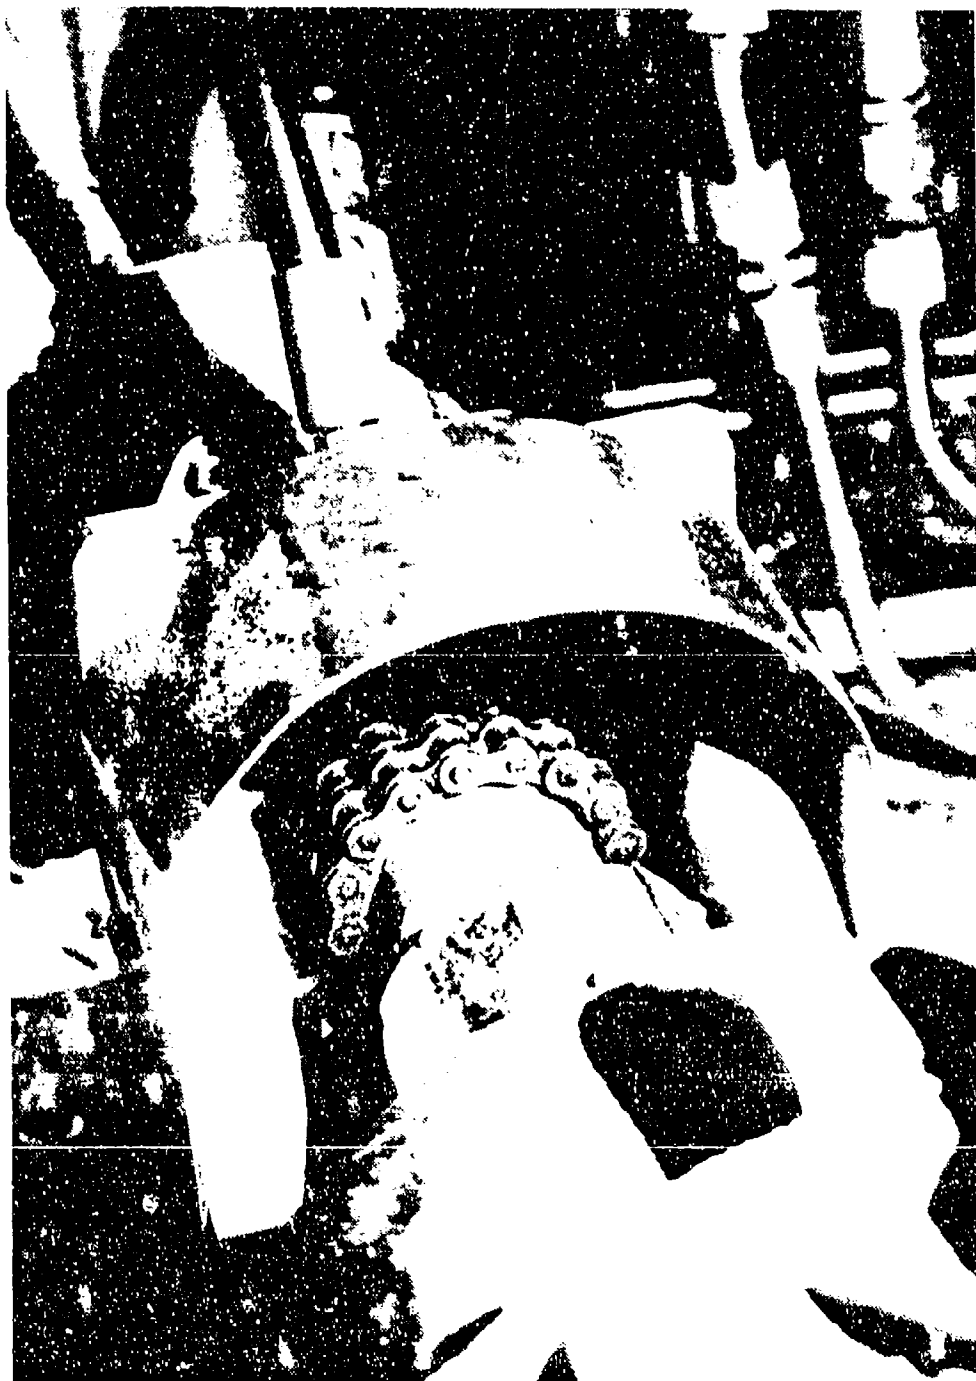
Photo 5. Roller Chain Coupling Between Hydraulic Motor and Water Pump

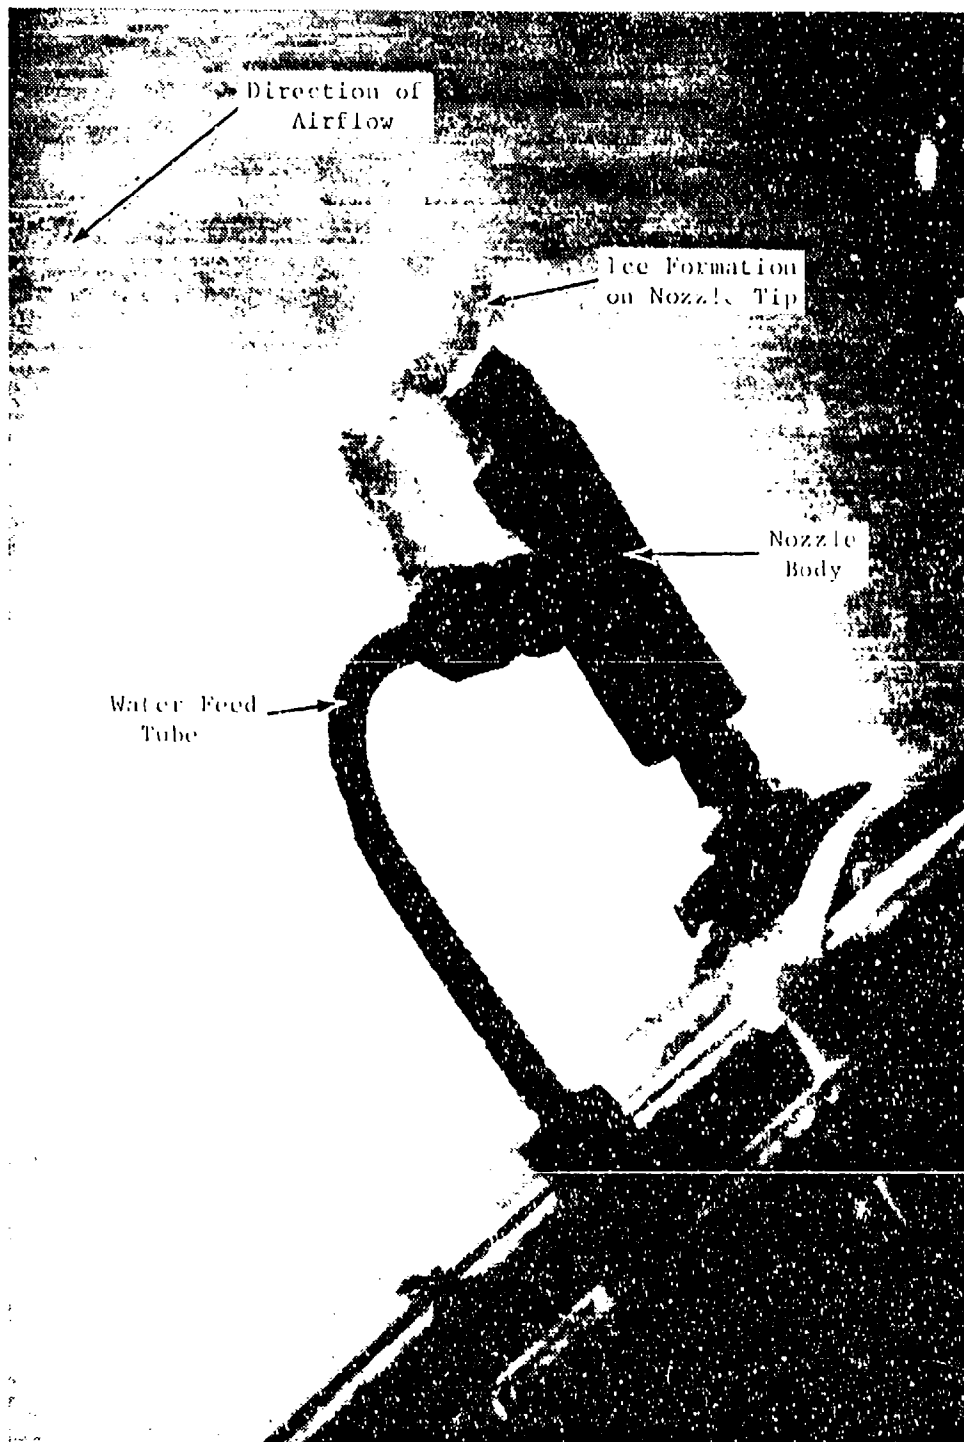
Photo 9. Ice Formation Between Atomizer Tip and Water Feed Tube

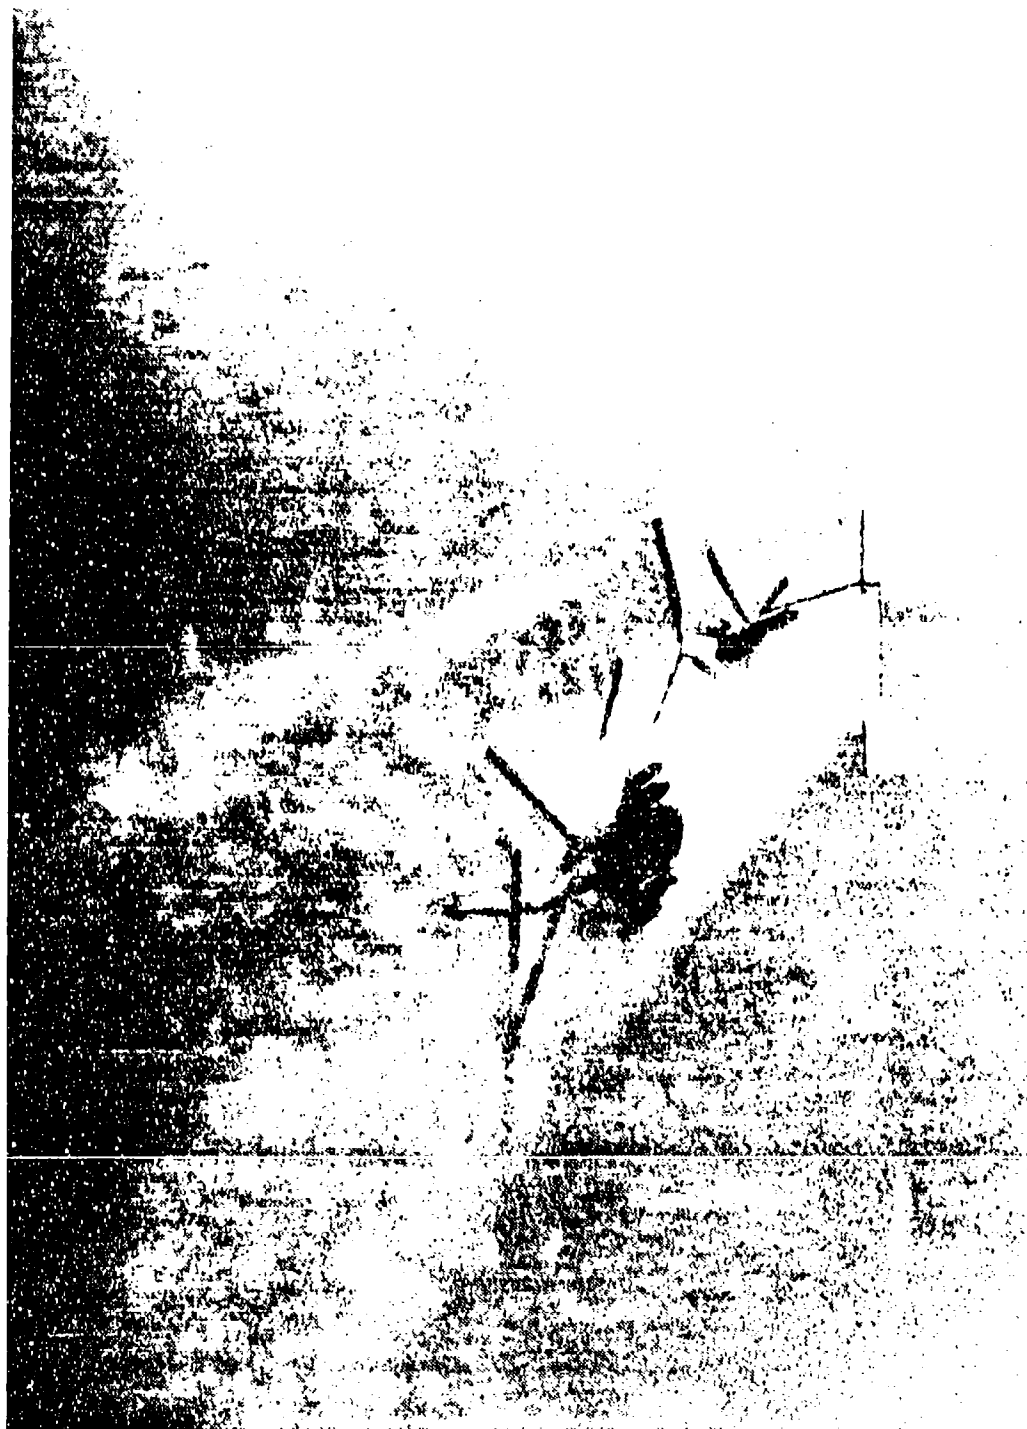
Photo 12. Condensation Trails Forming From HISS
Blade Tips at High Humidity (>95%)

35. High humidity conditions (above 95%) produced visible effects during spray operations. The appearance of the generated cloud became more dense and noticeably restricted forward visibility from the test aircraft. This was attributed to a large increase in the number of very small drops, which was also indicated by an increase in formation of frost-like coatings on the test aircraft (para 38). In such conditions, condensation trails frequently appeared in the rotor systems of both the HISS and the test aircraft (photos 12 through 14, app E). The visible vortices from the blade tips of the HISS passed well above the test aircraft, and the condensation trails could assume dimensions and appearance comparable to the spray cloud. The spray cloud did not dissipate as quickly as at low humidity and sometimes persisted in the form of parallel rows of clouds remaining from earlier passes back and forth through the test area. On a few such occasions, an undersun reflection could be observed in the previous trails, an optical effect indicating that the supercooled water drops had glaciated and turned to ice crystals (ref 16, app A). Photos 15 and 16, appendix E show a HISS cloud trail (as observed from the ground) that persisted, increased in size, and acted as a catalyst for natural cloud growth.

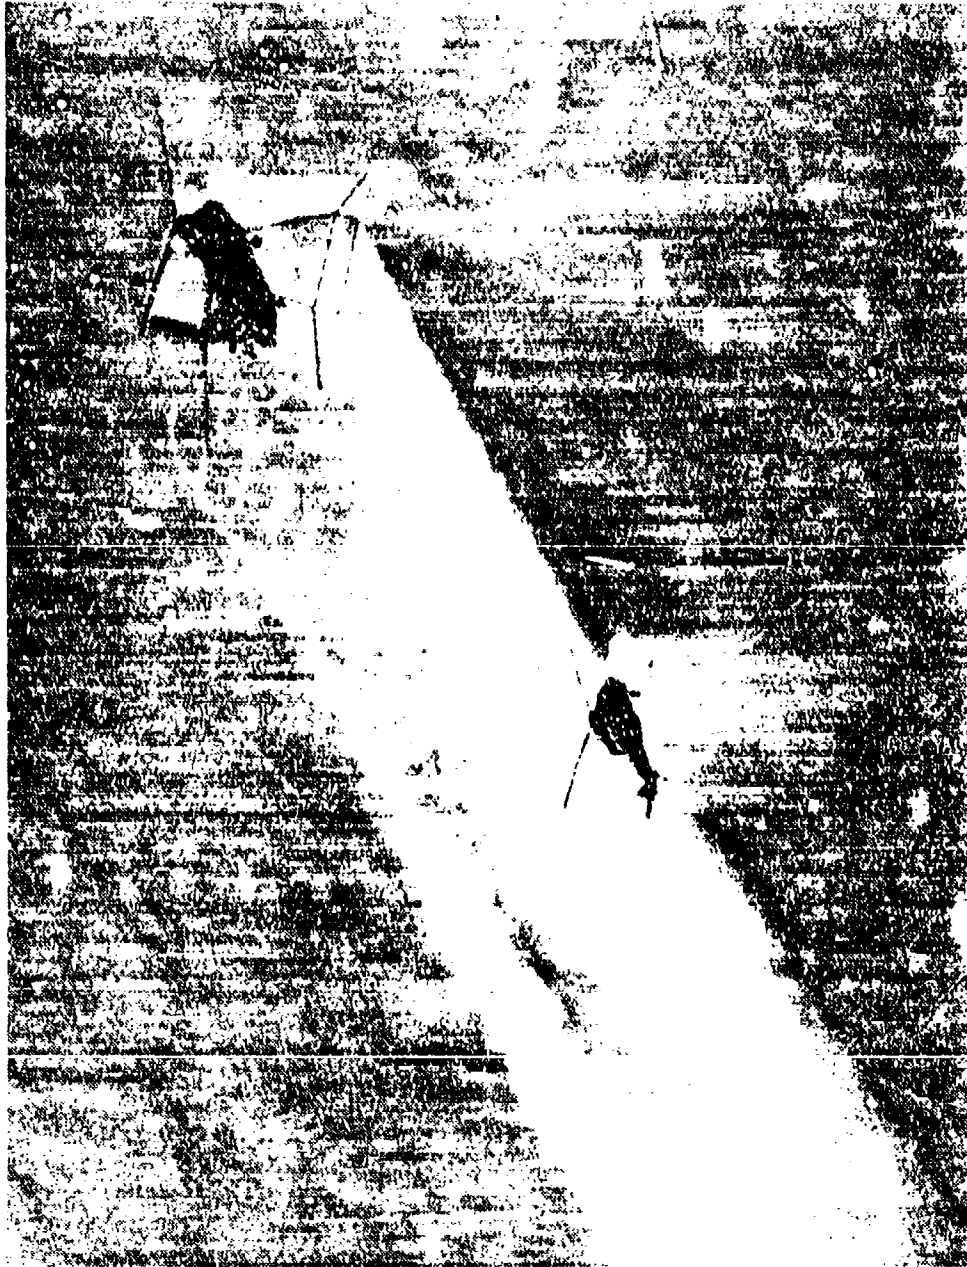
Photo 14. Expansion and Density Increase of Condensation Trails at
High Humidity (>95%)

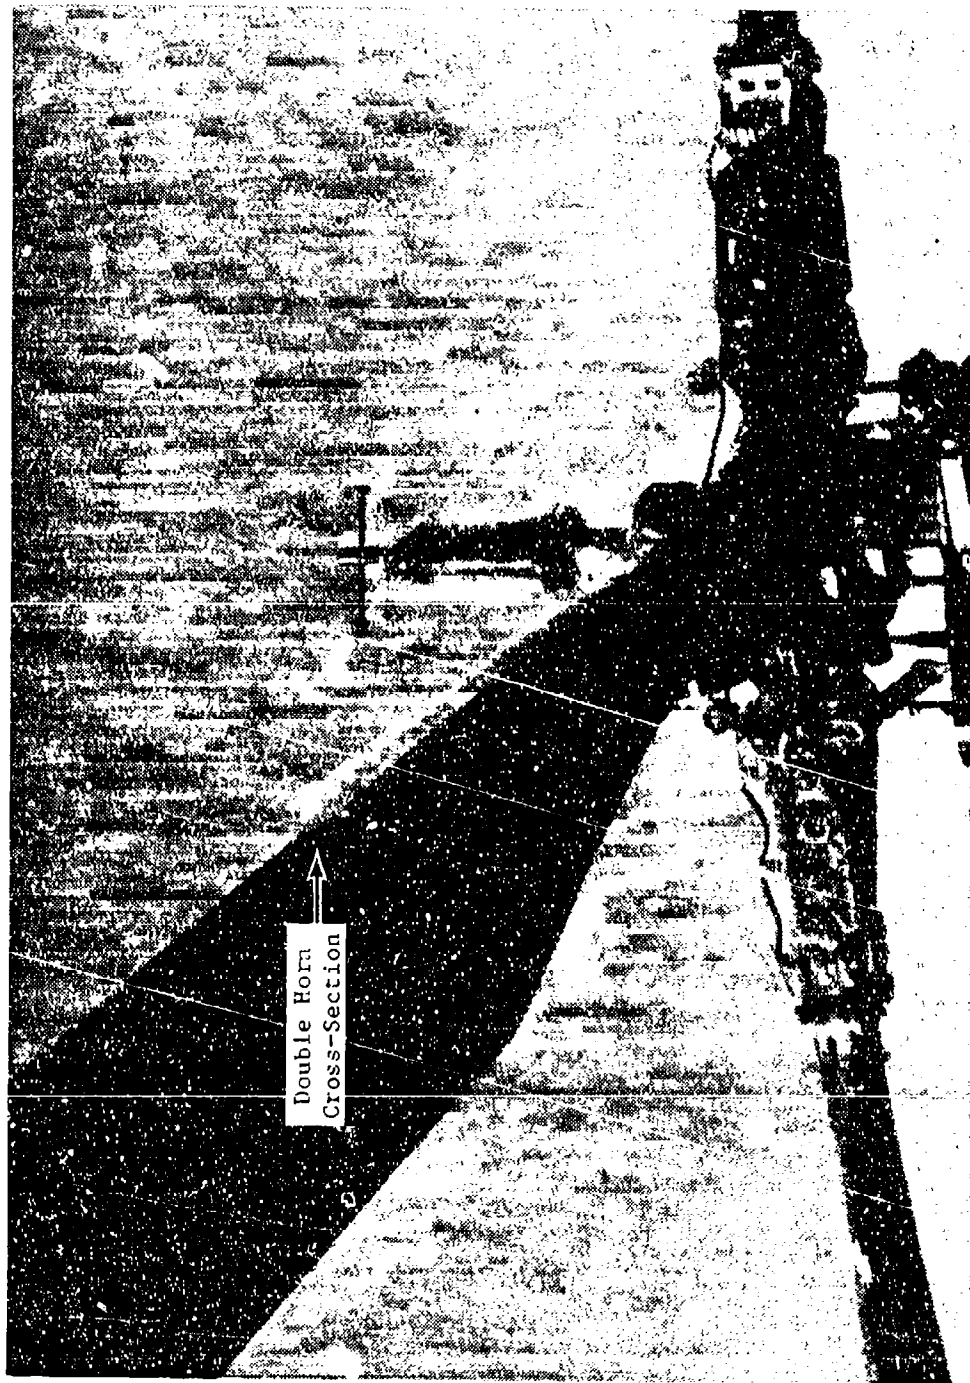
Photo 17. Artificial (HISS) Ice. "Double Horn" Shape on AH-64A Main Rotor After 22 Minutes at 1gm/m^3 , -5°C Ambient Temperature

38. Various inferences regarding drop size can be drawn from the appearance and characteristics of the ice accretions. Photographs 18 through 25, appendix E illustrate additional types of ice formations encountered in natural and artificial conditions. One indication of small drop size is formation of ice on surfaces that exclude large drops by inertial sorting. Tailboom rivets and small irregularities along the sides of a fuselage are examples of such areas, as shown in photos 18 and 19 for natural and artificial icing encounters. Photo 19 includes ice along the edges of stickon insignia letters on the tailboom, and a frost-like coating that follows skin surface deflections. At high-humidity conditions behind the HISS (para 35) the frost-like coatings became very pronounced, which is attributed to an increase in the number of small drops. Photo 20 shows such an instance where even the bottom of the fuselage was covered, resulting in a heavier coating than observed during natural encounters.

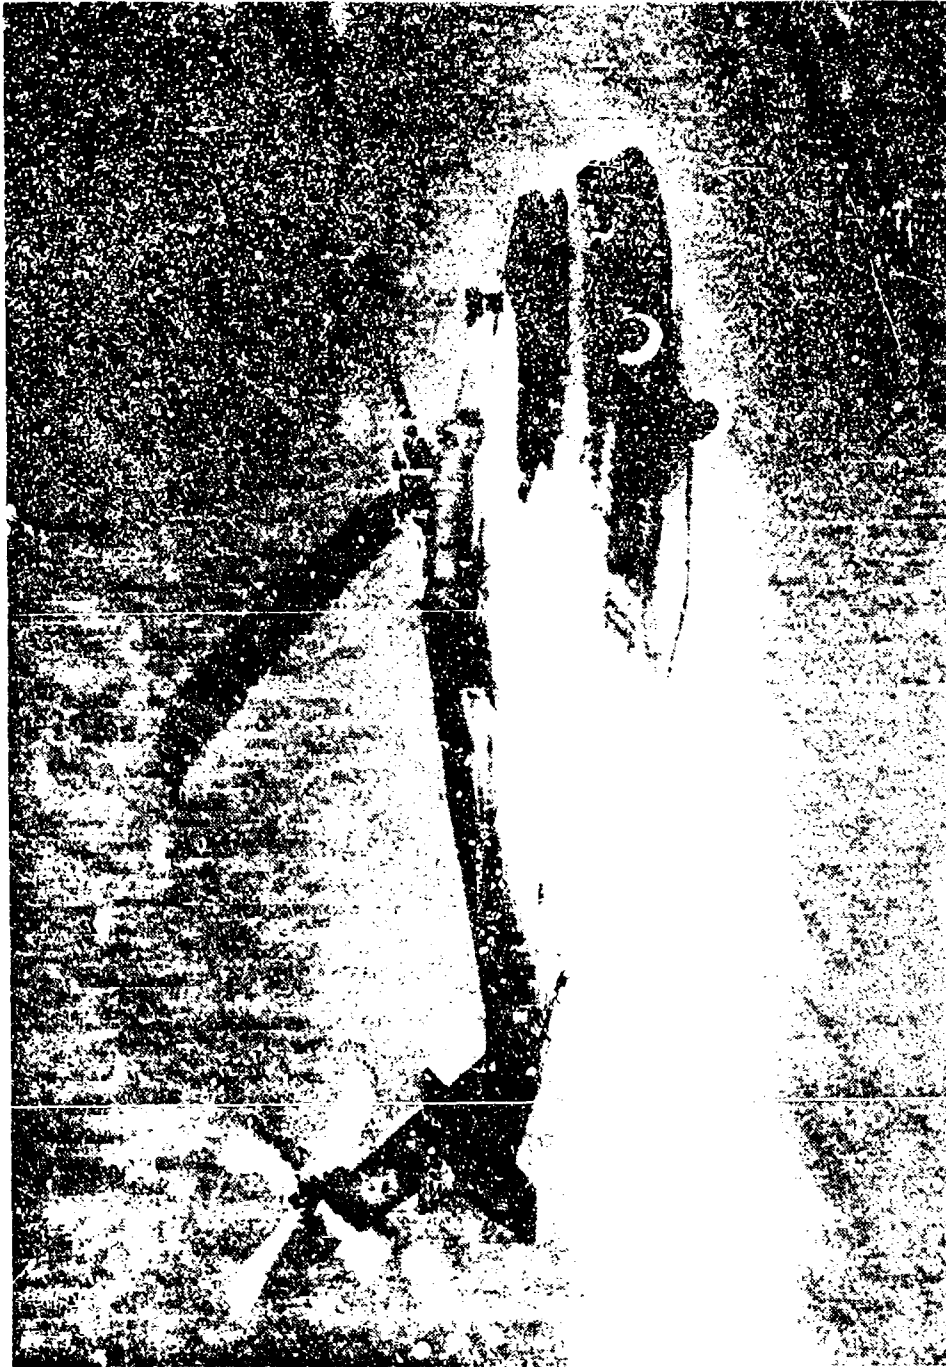
Photo 20. Artificial (HISS) Ice. Frost-Like Coating on Tailboom and Sides and Bottom of Fuselage at >95% Relative Humidity (UH-60; Bottom Half of Inboard Drop Tanks are Painted White, Rest of Airframe is Normally Dark)

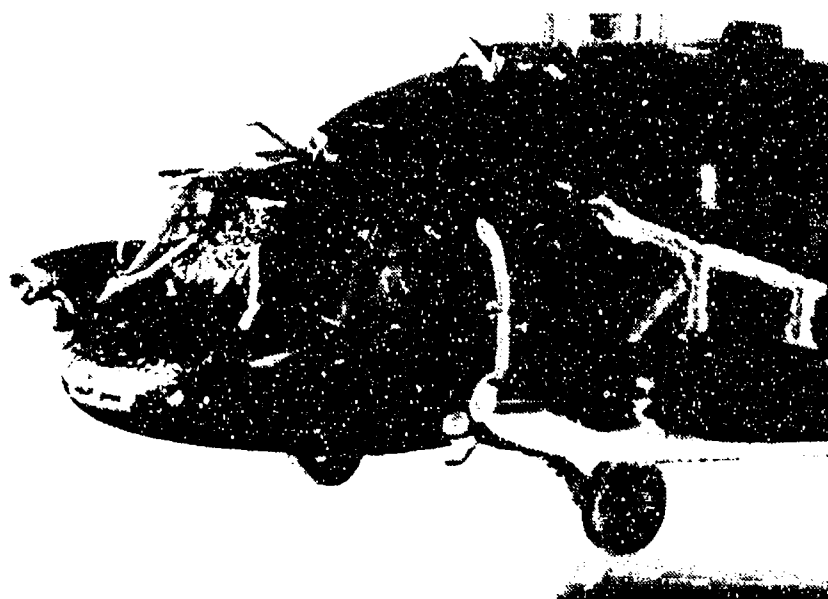
Photo 21. Natural Ice. Temperature -5.5°C ,
LWC 0.25gm/m^3 at $26\text{ }\mu\text{m MVD}$, 107 KTAS

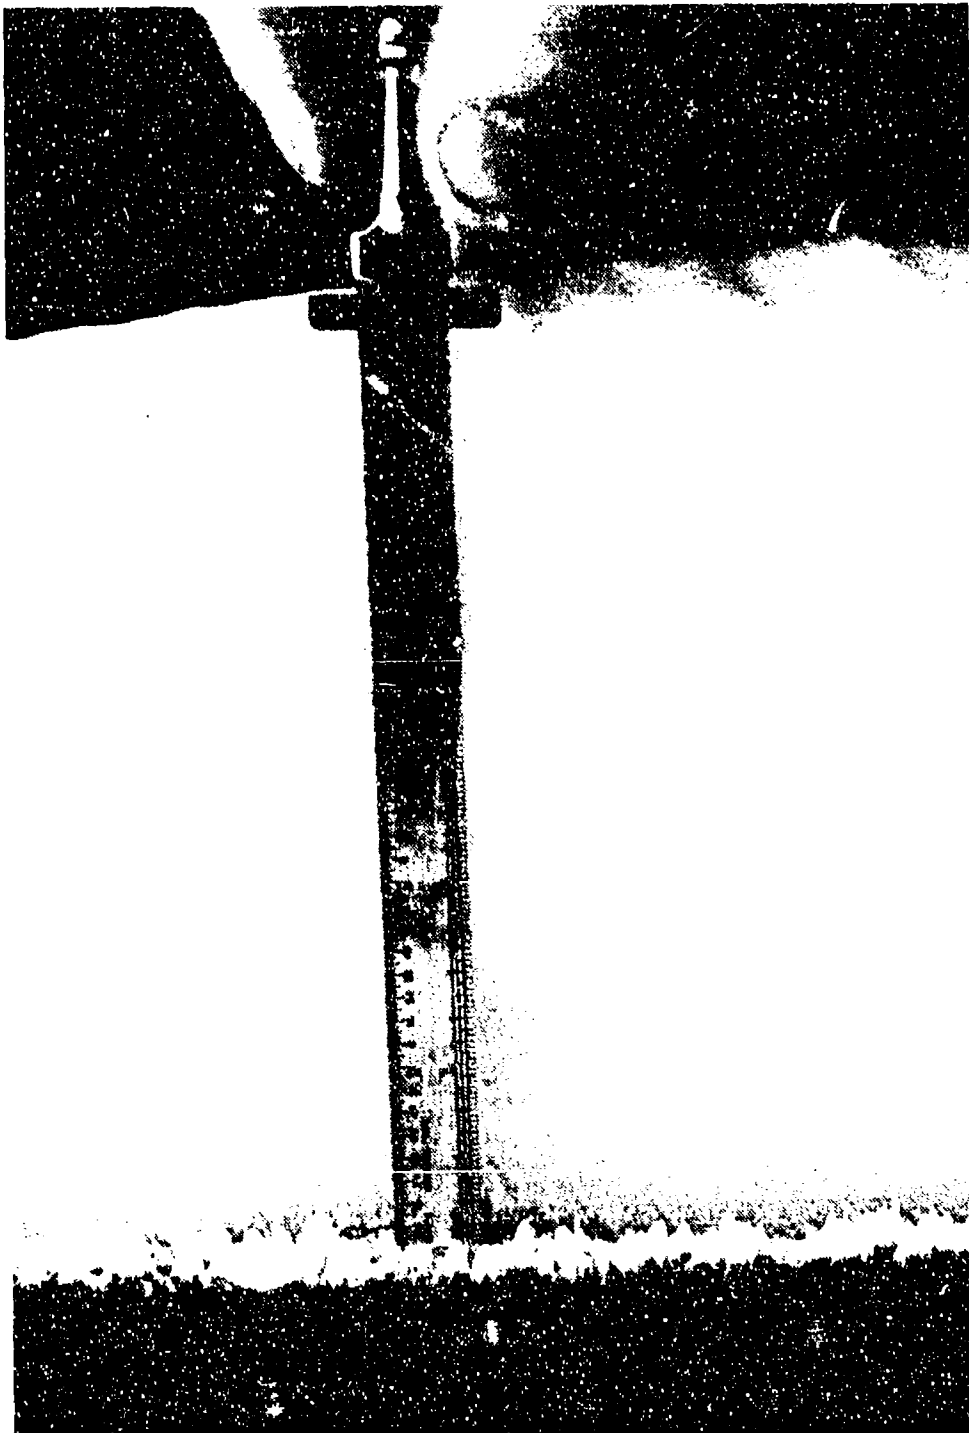
Photo 23. Artificial (HISS) Ice. Formation on FM Antenna of UH-60 Helicopter
